Article

Vision-Based Pavement Marking Detection and Condition Assessment—A Case Study

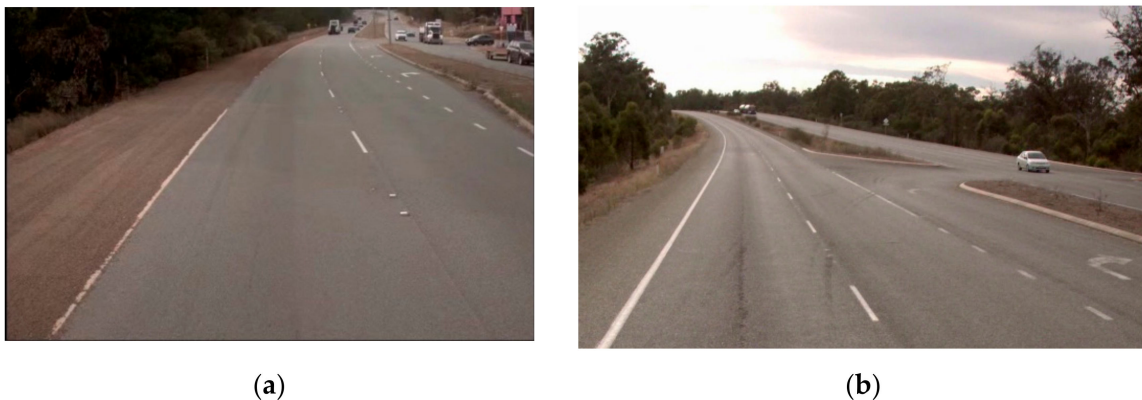
Figure 1. Examples of pavement markings in poor condition. (a) Edge line (left side) is worn down and even missing; (b) turning arrows and continuity line (right side) are blurred.

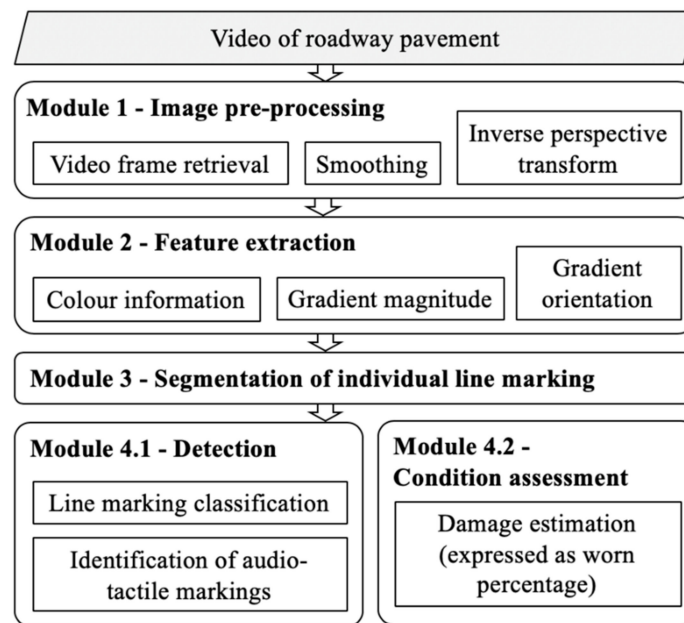
Figure 2. Flowchart of vision-based lane line detection.

The proposed vision-based framework for line marking detection and condition assessment can be best understood as a flowchart. Figure 2 maps the overall structure of this scheme, and four modules will be illustrated in detail.

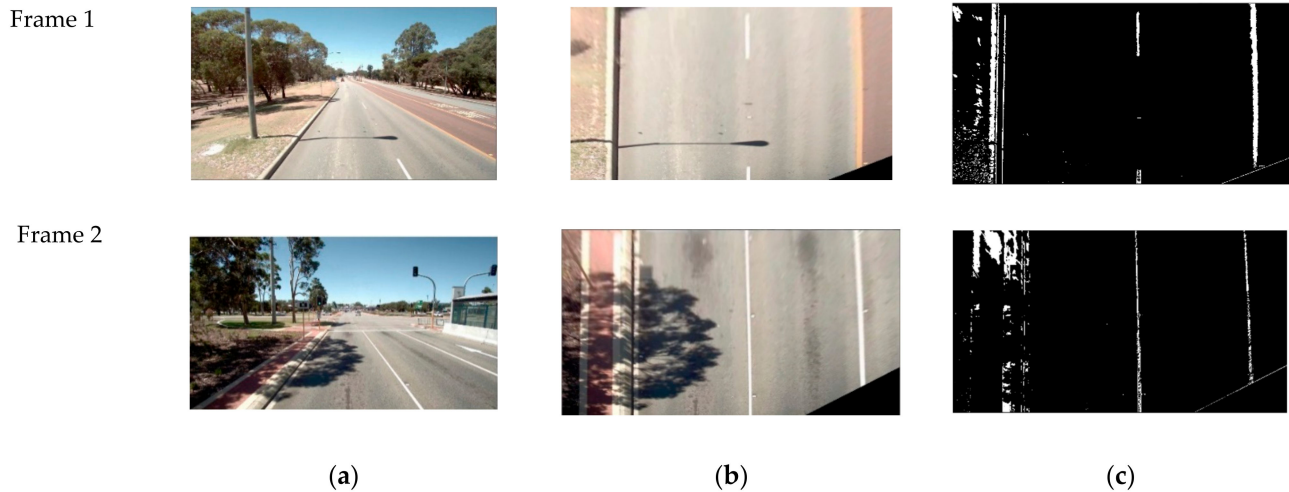
Figure 3. Test of the feature extraction method on pavement images. (a) Original images; (b) results of inverse perspective transform; (c) results of feature extraction.

of pavement images, and Figure 3 shows a few of the results. The road segment for preliminary tests is located in a metro area and the results indicate that shadows and rutting on pavement can be successfully eliminated.

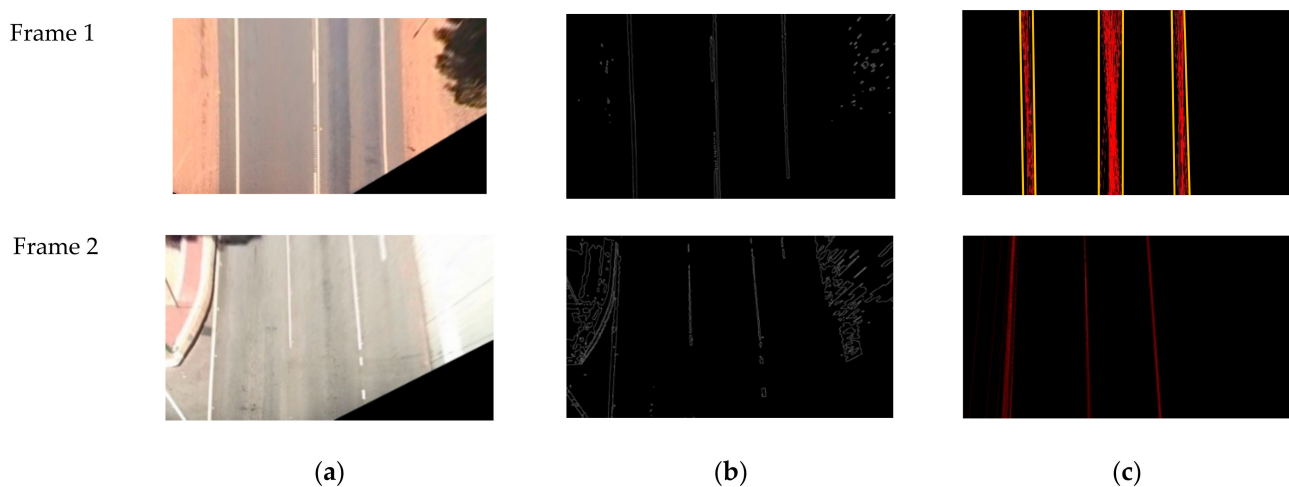
Figure 4. Test of the segmentation method on pavement images. (a) Planar images; (b) results of Canny edge detection; (c) results of Hough line transform and grouping.

Based on the extracted features, this module applies segmentation on the planar images. Segmentation, also known as grouping or fitting [41], aims to generate distinctive and informative summary representations of pixel groups, which are individual line markings in this case. Single markings are selected and exported as separate image files. To locate pavement marking instances, Canny [42] is used for edge detection, whose outcomes are later fed into a Hough line Transform algorithm. Hough Transform [43] has been intensively used for line detection, which tests links between any random point pairs and select ones with higher votes than the user-defined threshold. To further eliminate outliers, lines with unreasonably large slopes are removed, and those belonging to non-marking areas are also filtered out according to their spatial positions. A grouping method is then applied to determine individual line marking areas. The proposed segmentation method was also tested on the same set of sample images. Figure 4 presents the results.

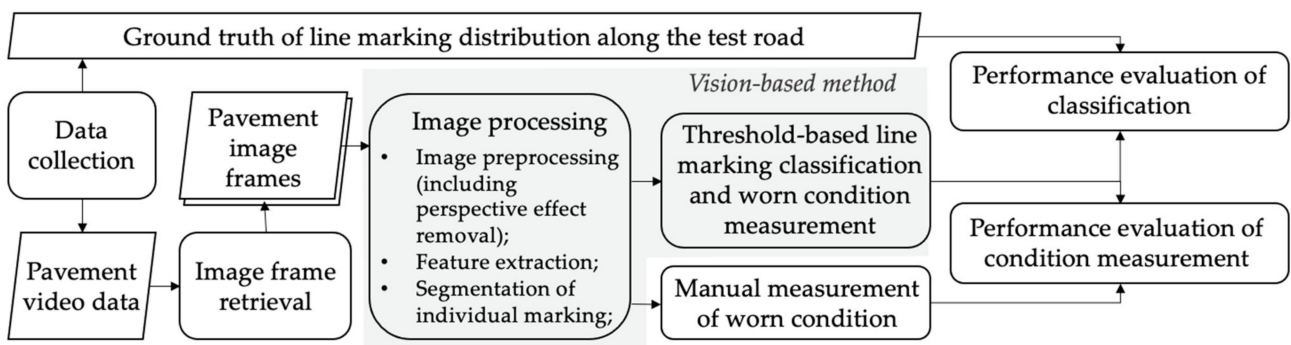
Figure 6. Flowchart of case study.

To evaluate the applicability of the proposed framework for vision-based pavement marking detection and condition assessment, a case study on a real-life roadway pavement was designed and carried out. Main Roads Western Australia (MRWA)—the road agency of the Government of Western Australia—archives pavement video data of their roads. Such videos were originally recorded by a vehicle traveling at a uniform speed in both directions of traffic movement. This data collection method ensures that each frame in the video covers approximately a 20 m long road segment, and therefore, far field regions of the pavement can be eliminated for the current frame and analyzed in the next frame. Additionally, the two-direction filming method is especially necessary for roads in metro areas since they are normally too wide to fit into the camera’s field of view. A videotape recording a total of 28 km highway pavement in Western Australia was retrieved. Preliminary tests were run beforehand to evaluate the performance of the candidate methods for each module. Next, a case study was conducted to further validate its effectiveness. The case study can be understood as a flowchart, as shown in Figure 6.

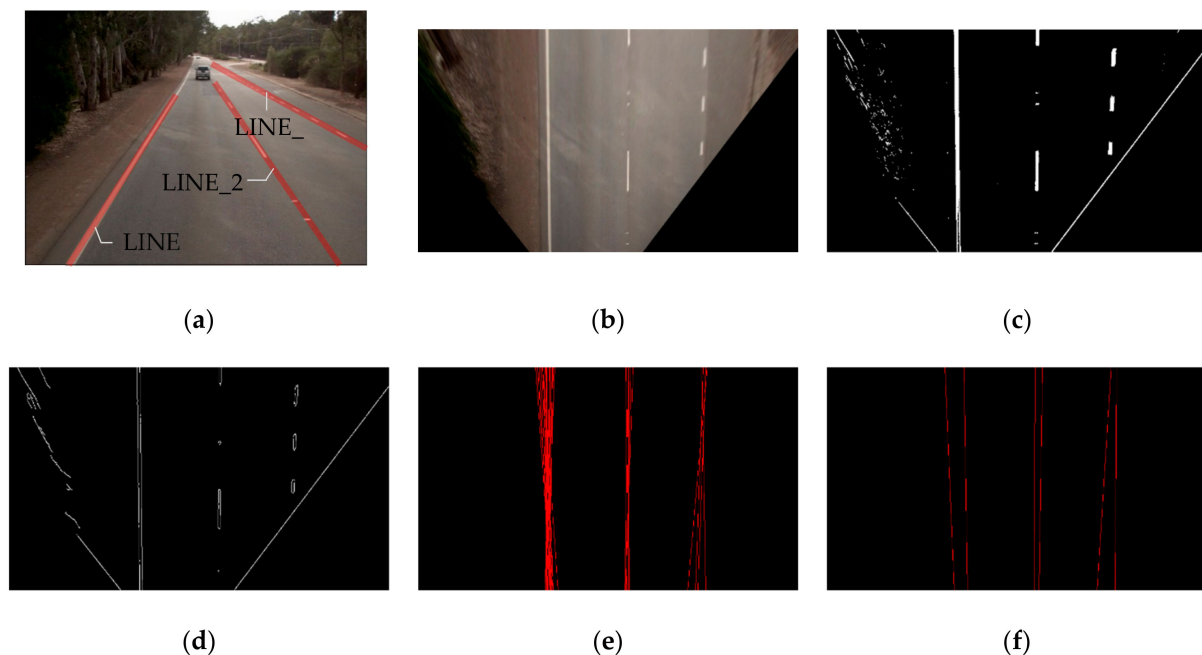
Figure 7. Illustrations of image processing steps, including: (a) original image; (b) bird's eye view image; (c) output of hybrid descriptor; (d) output of Canny detector; (e) result of Hough transform; (f) result of segmentation.

Based on road-plane images, features were then extracted. The hybrid feature extraction method tested in Section 3.2 was modified, by customizing the color feature detector for different line markings. A three-channel filter was used in the HSL color space for yellow markings and a one-dimensional filter was used in the gray-scaled image for white markings. Thresholds were determined to cope with intra-color variations and successfully distinguish inter-color differences. Based on the information for both color and shape (extracted using Sobel operation), a feature map of the pavement markings can be obtained for analysis. The result is shown in Figure 7c.

To further isolate individual line marking for classification and analysis, a combination of Canny edge detection and Hough line transform was utilized, as detailed in Section 3.3. Key parameters in this approach, i.e., the minimum length of lines and the maximum gap between two feature points that belong to the same line, were pre-defined so as to leave out noise from the surroundings. Outlier lines were further removed with regard to their slopes and spatial placement. Figure 7a–f illustrates each step of the image processing method. It shows that a binary feature map of line markings can be obtained and the region of interest (i.e., individual markings) can be successfully segmented.

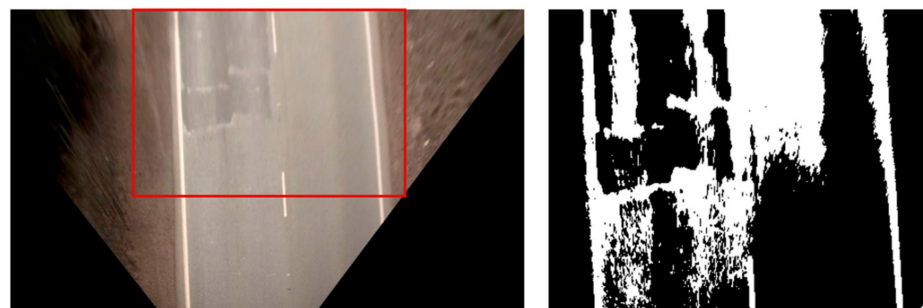
Figure 8. Example of polished pavement.

A range of environmental factors account for the detection failures. The road segment in Figure 8 has an extensively polished pavement surface and patches, generating a misleading feature map (shown in the right image). As a result, both the left edge line and the dividing line were mistakenly identified as “Other”. Another notable disturbance hindering accurate classification is vehicles on adjacent lanes, which causes severe occlusion. Such situation typically occurs when overtaking is occurring, and thus, it lasts no more than five frames. Temporary loss of line marking detection in some image frames can be supplemented by referring to their context in the time sequence. Curbs and railings alongside the road, as shown in Figure 9b,c, can also lead to detection errors.

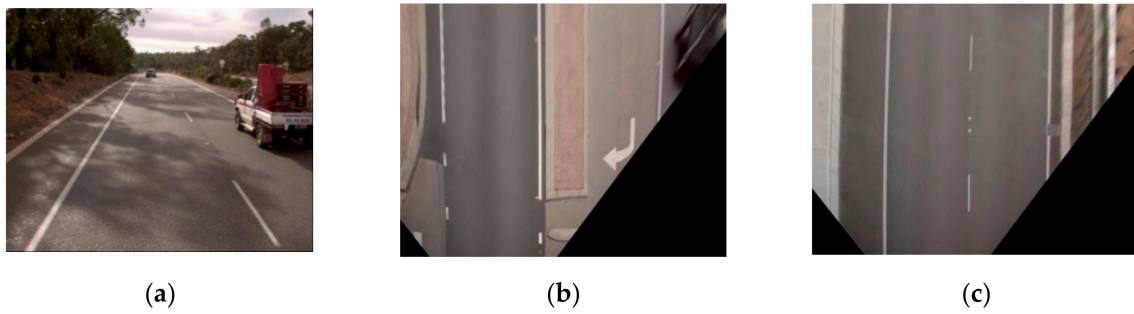
Figure 9. Other noises affecting classification, including: (a) occlusion from other vehicles; (b) curb; (c) road-side railings.

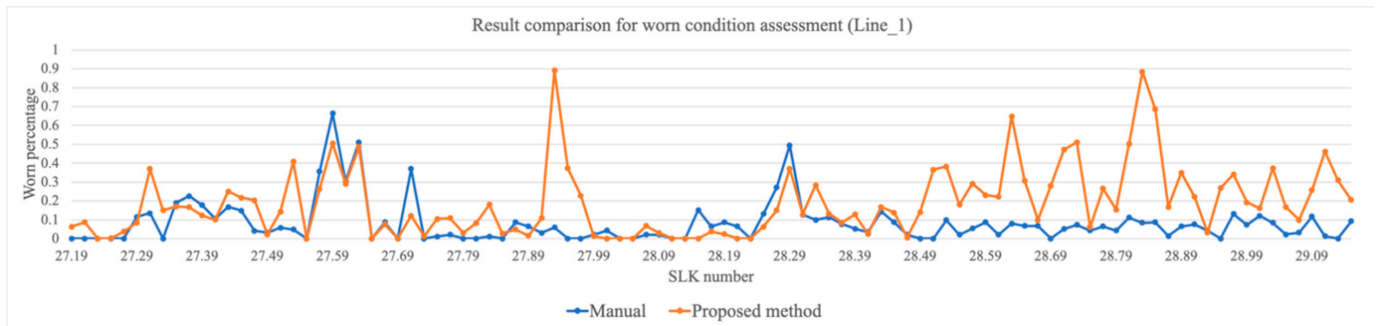
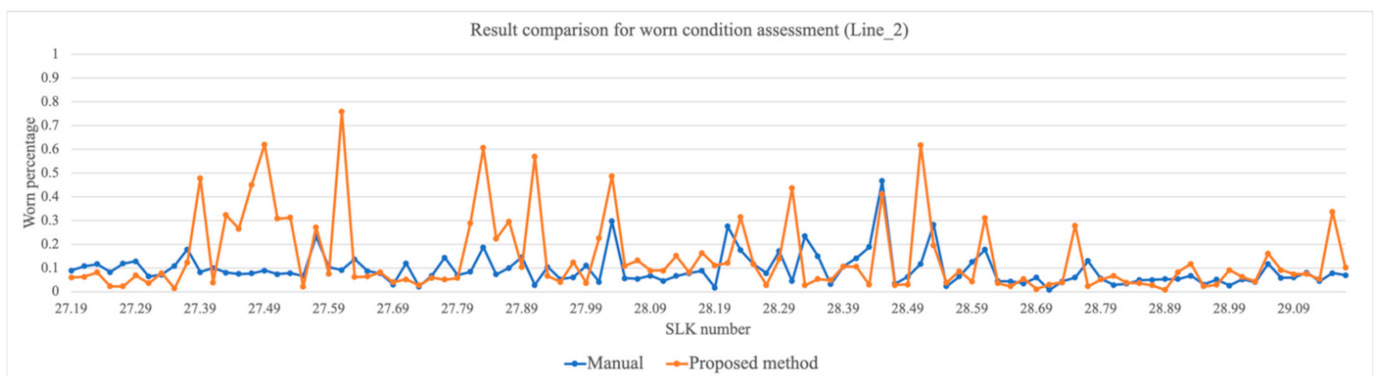
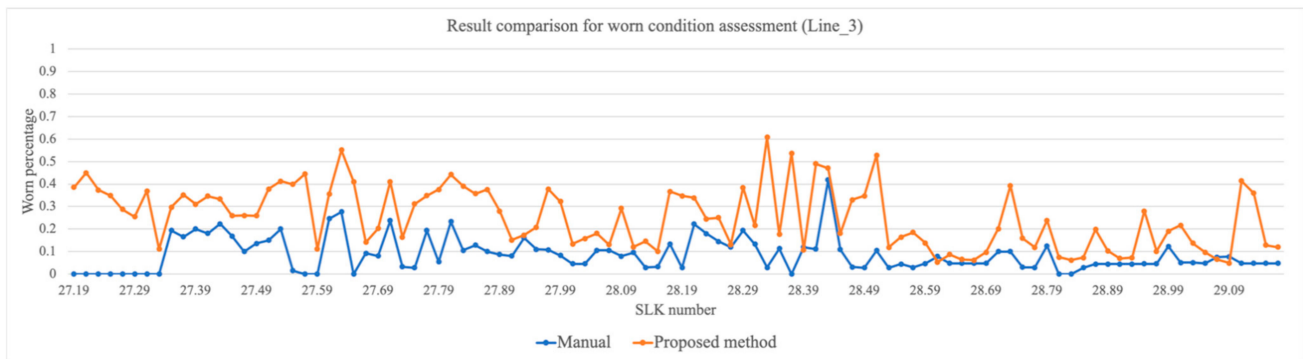
Figure 10. Comparison of worn condition assessment results. (a) Result comparison for Line 1; (b) result comparison for Line 2; (c) result comparison for Line 3.

To validate the proposed approach for condition assessment, a roughly 2 km long road segment was further retrieved randomly. To generate a benchmark for their worn condition, images were first superimposed onto a grid and the worn percentage of line marking instances in each image frame were manually measured by the author. The minimum spacing of the underlying grid is five pixels, and therefore, the manual measurement could possibly reach an accuracy of one pixel. Comparisons between the manual measurement and the results of the proposed method are plotted on line charts. Figure 10 presents the result comparison charts for LINE_1, the nearest line marking to the camera to the left, and LINE_3, the farther boundary of the adjacent lane, as illustrated in Figure 7a. The horizontal axis represents the corresponding SLK (Straight Linear Kilometer) number of each frame, as recorded in MRWA’s management system, while the vertical axis is the estimated worn condition in terms of percentage.

In Figure 8, the worn condition evaluated by the proposed method fits the worn condition assessed through manual measurement, though the former tends to present a higher worn percentage than humans do. For example, it is noted that in Figure 10a, between SLK 27.55 and SLK 27.65, there exists a peak indicating extensive wear of line marking. By referring to the original video data, we found considerable tracing ruts on the marking, as shown in Figure 11a. Similar deteriorations of line marking can be found at SLK 28.23~28.33 (for LINE_1), SLK 28.41~28.47 (for LINE_2 and 3, as shown in Figure 10b, etc. However, there are false warnings for poor marking conditions in both charts (e.g., SLK 27.89~27.99 for LINE_1 and SLK 28.34~28.39 for LINE_3). Such errors are mainly attributed to the color-based feature extractor, which is subject to the changing illuminations and shadows of road-side objects. Figure 12 shows image frame at SLK 27.93, where yellow continuity lines are reduced to only its edges and thereby, received incorrect worn condition results.

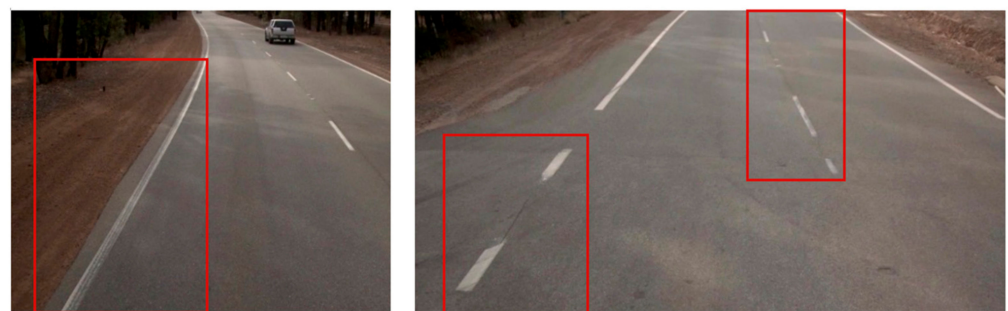
Figure 11. Example frames of worn line marking. They are located at (a) SLK 27.59; (b) SLK 28.45, separately.

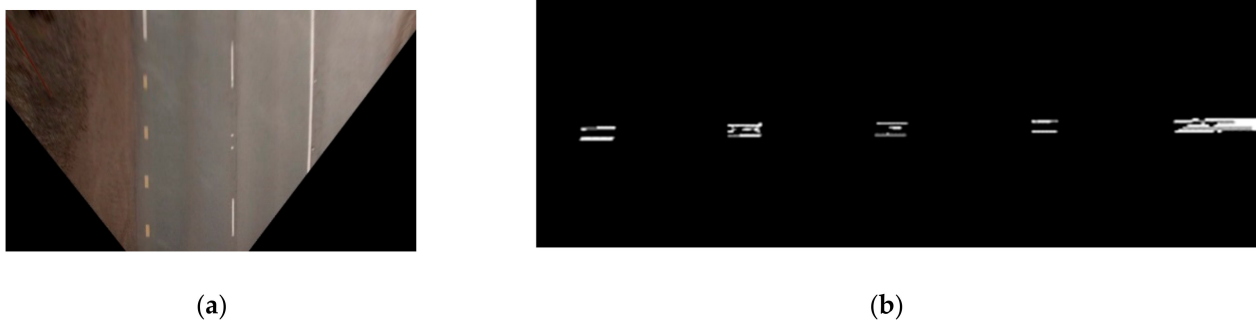
Figure 12. Example frame of false worn condition. (a) Planar image; (b) binary feature map of the yellow line marking.

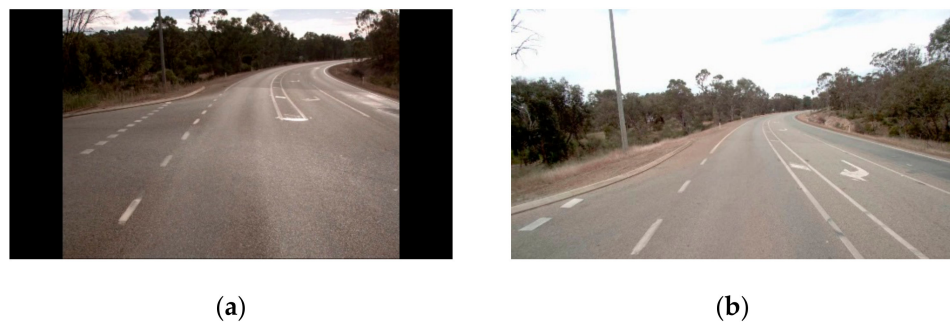
Figure 13. Example of camera shift during recording. (a) Previous frame; (b) next frame.

In the case study, the removal of perspective effects in original video frames relied on the manual selection of feature points. However, human intervention with the aim of obtaining a satisfactory overhead view of road pavement is not a one-off, since the shooting direction of the camera shifts while the vehicle is moving forward. Figure 13 shows two adjacent frames, where there is a sudden change in camera's shooting angle. In addition, incremental deviations from the initial camera settings regarding the lane also have adverse impacts on the performance of pre-processing. As a result, re-calibration of the camera is required so as to successfully remove perspective effects in the captured images. A pre-calibrated camera and its stability throughout recording will greatly facilitate the automation.
