## *500 Collins Street, Melbourne, Victoria*

### *Building Profile*

### *Overview*

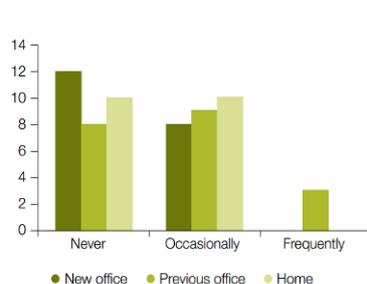
**Figure 19 – Frequency of headaches in the office or at home**  
(Source: Bevege, 2006)

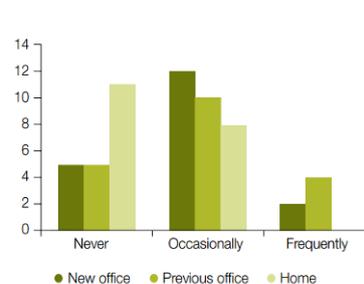
**Figure 20 – Frequency of poor concentration in the office and at home**  
(Source: Bevege, 2006)

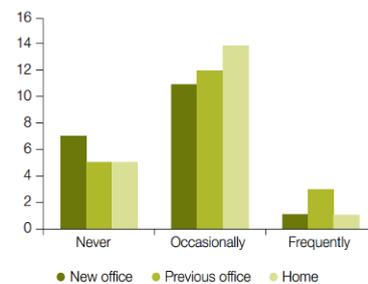
**Figure 21 – Frequency of cold and flu in the office and at home**  
(Source: Bevege, 2006)

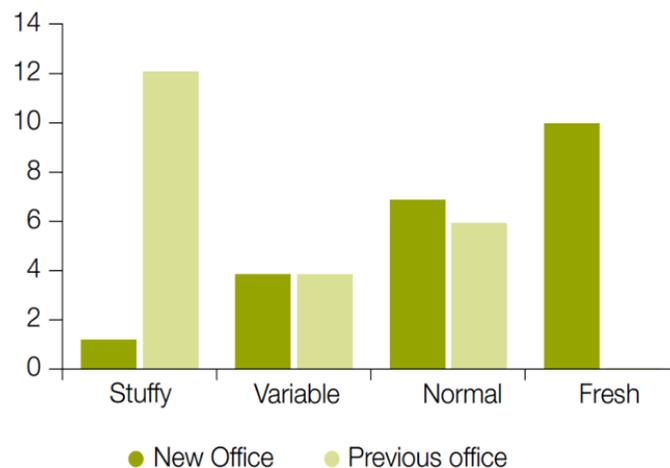
Figure 2: Occupant responses for perceived air quality before and after refurbishment<sup>33</sup>

Staff surveys of employee productivity in 500 Collins Street pre- and post-refurbishment reveal the following.<sup>32</sup> As indicated in Figure 2, when staff were asked to rate air quality within a range from ‘stuffy’ to ‘fresh’, the results showed a dramatic improvement in staff perceptions of air quality in the refurbished office. Based on this response, the fresh air index improved from –10 before the refurbishment to +9 after it (Figure 3).

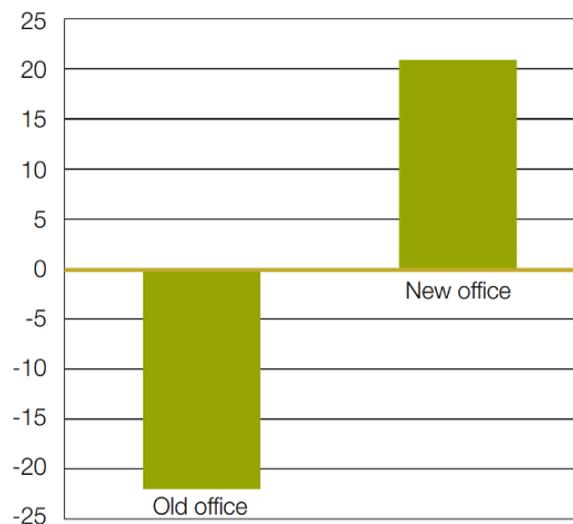
Figure 3: Fresh air index in the office space before and after refurbishment<sup>34</sup>

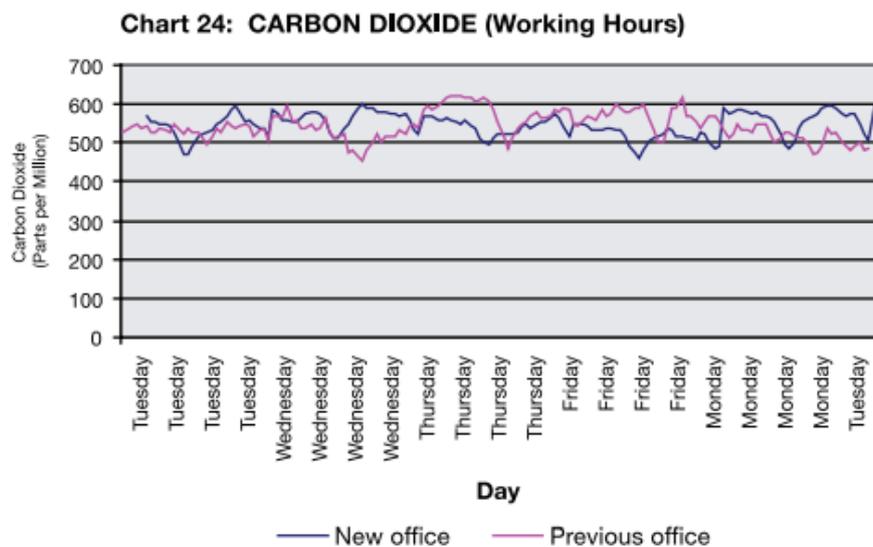
Indoor environment quality analysis was performed in the building pre- and post-refurbishment, including sampling of key IEQ parameters such as carbon dioxide, carbon monoxide, temperature and humidity.<sup>35</sup> Carbon dioxide measurements show that levels were low in both the pre- and post-retrofit offices, showing no statistically significant difference between the two.<sup>36</sup>

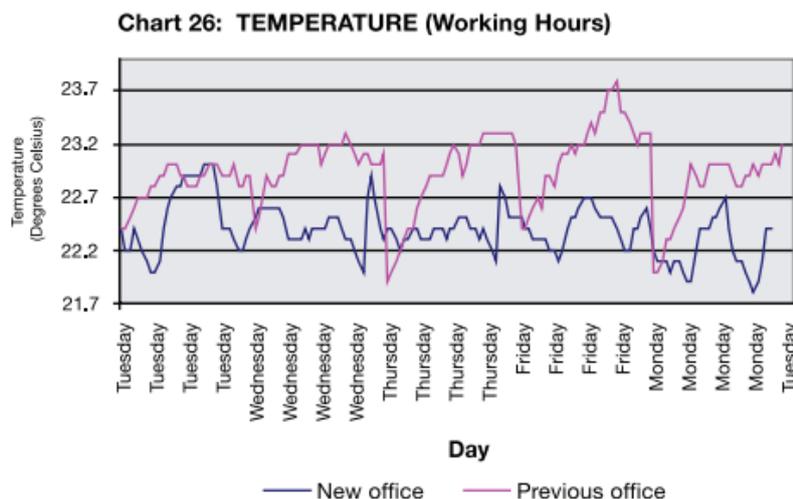
Likewise, recorded temperature and humidity levels were within acceptable limits in both the pre- and post-retrofit offices.<sup>37</sup>

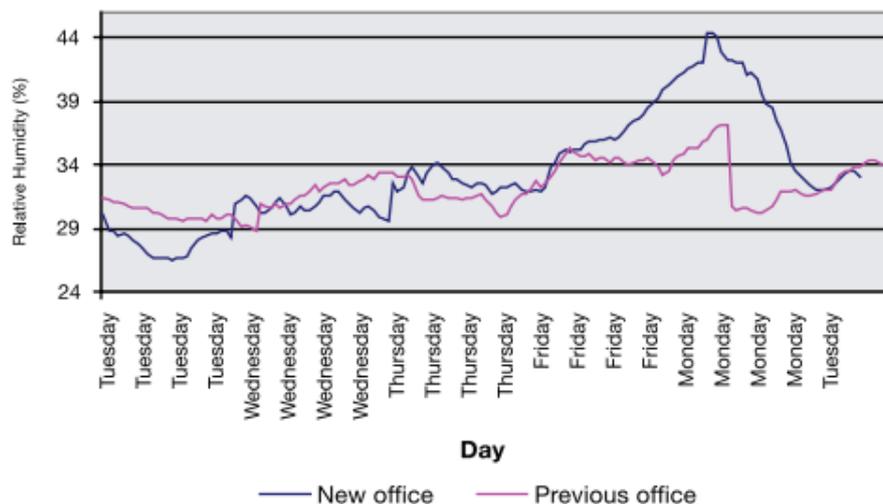
**Chart 34: RELATIVE HUMIDITY (Working Hours)**
