Resilient Buildings: Informing Maintenance for Long-term Sustainability

Final Research Report

Part 4: Development of a maintenance prevention strategy to mitigate wind-driven rainwater ingress through windows and external glazed doors in social housing

Prepared by Juliana Faria Correa Thompson Flores (Primary author), Kris Harm, Rodney Anthony Stewart, Edoardo Bertone, Oz Sahin; *Griffith University*

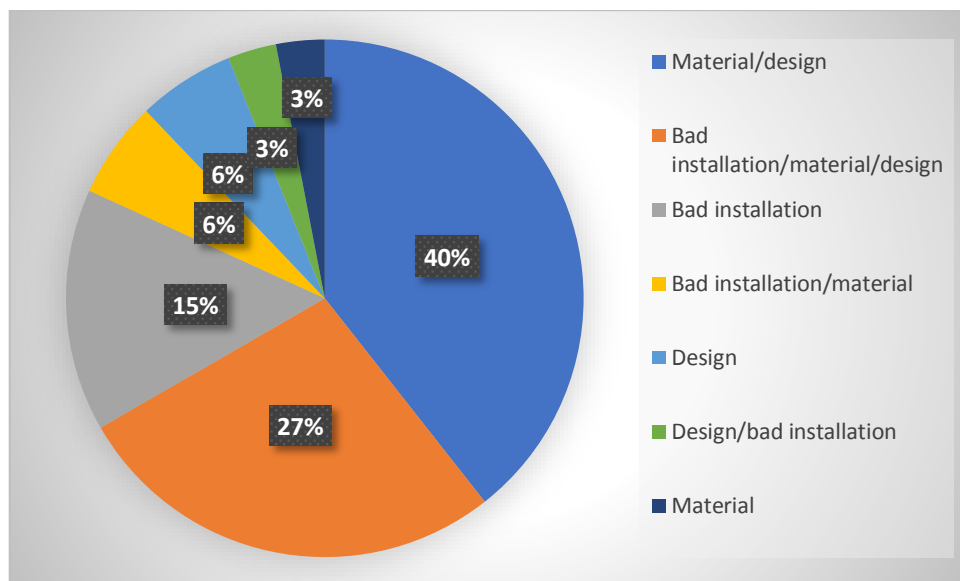
Figure 3 Categorisation of non-structural failures in buildings investigated in CTS reports No.63 and No. 57

The analysis of the table resulted in identification of a set of categories of failures (**Figure 3**):

1. Material/design
2. Bad installation/material/design
3. Bad installation
4. Bad installation/material
5. Design
6. Design/bad installation
7. Material
